INSPECTION REPORT
2148 E Camino La Zorra
Tucson AZ 85718

INSPECTED BY
Robert Tackett
House and Home
LLC
73765

INSPECTION DATE
📅 7/8/2024
🕒 01:00 PM

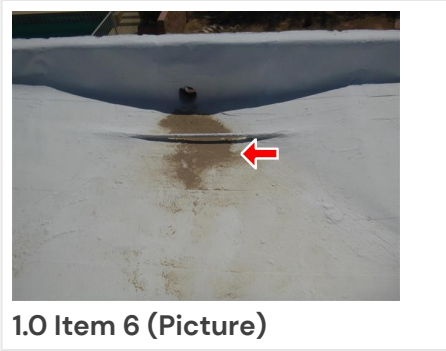
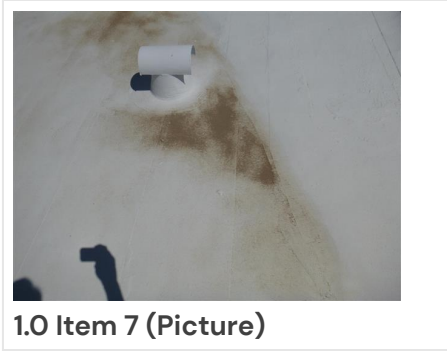
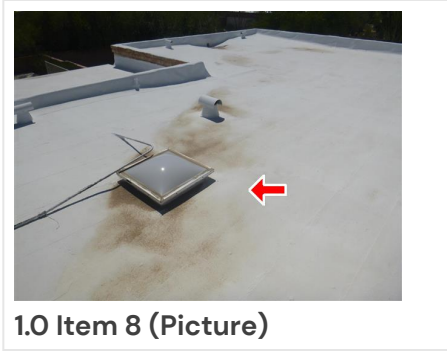
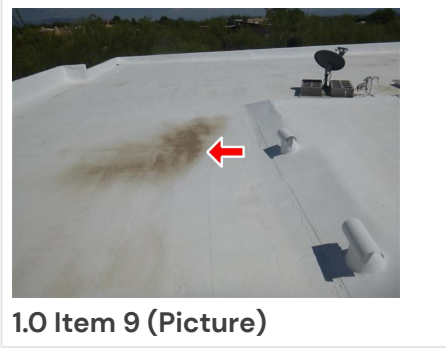
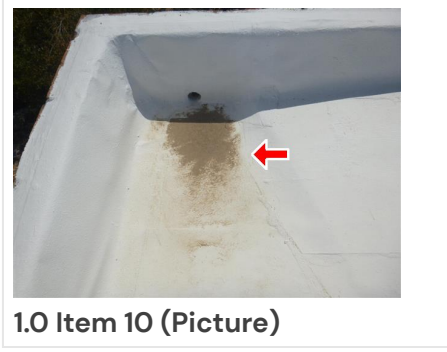
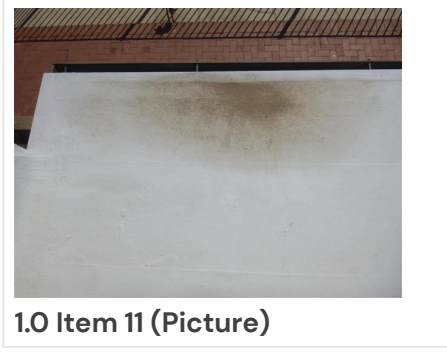
(2) Areas of ponding on the roof. Advise building-up areas to allow for proper drainage by a roofing contractor.

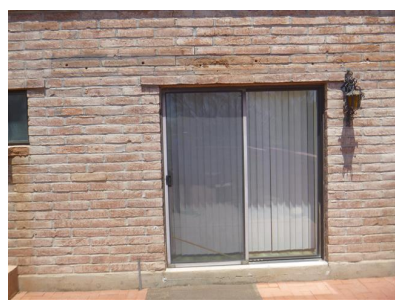
2.0 Item 1 (Picture)

Fine cracking noted in brick exterior. Cracks are less than 3/16 " (about the width of a quarter) and with no displacement. These cracks are most likely due to foundation settlement and are not structural. Advise filling the cracks with mortar and monitoring for further movement.

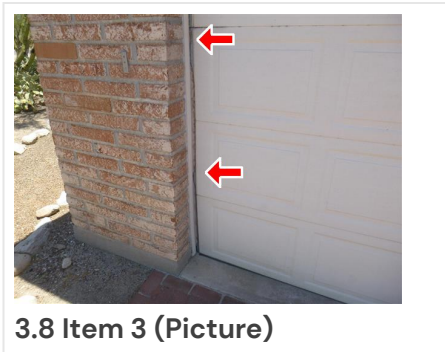
3.8 Item 3 (Picture)

(2) Loose / damaged garage door side seal noted. Advise securing garage door side seal to prevent possible pest and/or moisture intrusion.

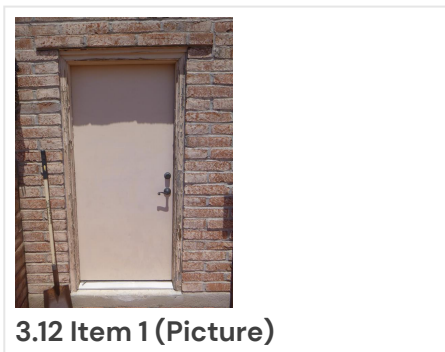
3.12 Item 1 (Picture)

Wood decay/damage noted at the threshold and door jamb. Advise further evaluation and repairs by a door company or qualified party.

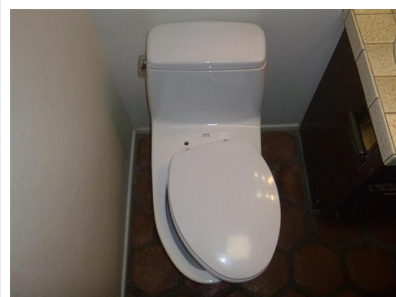
6.1.C Item 1 (Picture)

The toilet functioned as intended when tested but has a loose toilet seat. Advise securing seat as needed by a qualified party.

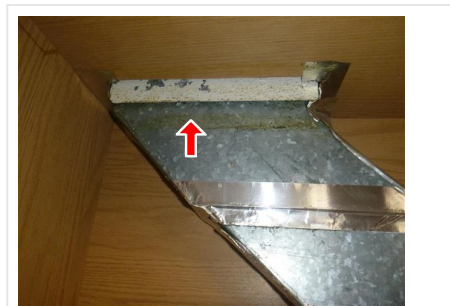
7.11 Item 2 (Picture)

(2) Air leaking into the cabinet from the duct for the exhaust hood. Advise repairs as needed to seal duct.

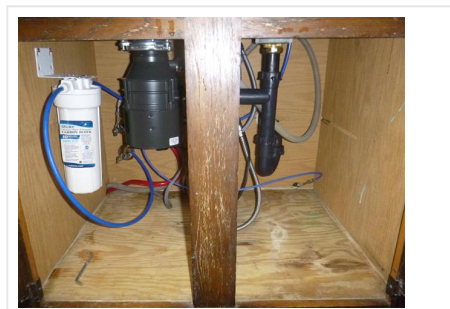
7.12 Item 1 (Picture)

Water staining noted at the kitchen sink cabinet. No moisture or leaking noted at the time of the inspection but signs of black mold like material. Advise further evaluation by a mold inspector and monitoring area for a worsening in condition and repairs as needed.

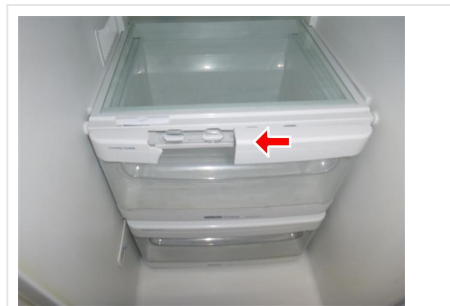
7.14 Item 4 (Picture)

(2) One of the drawers was damaged at time of inspection. Advise repairs as needed by a qualified party.

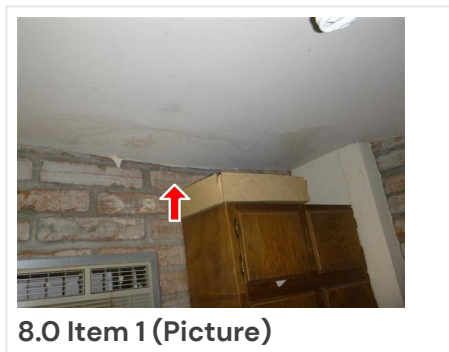
8.0 Item 1 (Picture)

(1) Moisture staining and drywall sagging noted at the garage closet ceiling in the corner. No moisture present at time of inspection. Advise further evaluation of roof at this area by a roofing contractor.

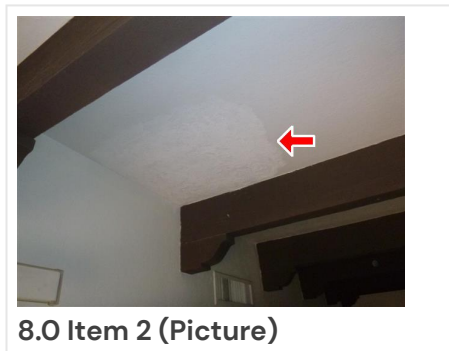
8.0 Item 2 (Picture)

(2) Un painted drywall repairs noted. Advise painting patches as needed.

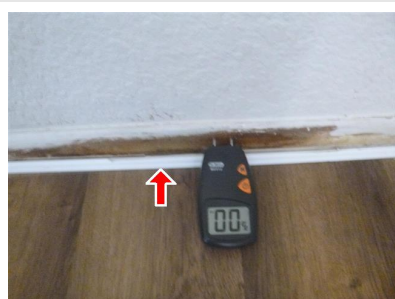
8.1 Item 1 (Picture)

(1) Moisture staining noted at the bedrooms and closets that are in contact with the exterior mechanical closet on the left side of the home. There was no moisture present at time of inspection. Advise further evaluation of roof at this area by a roofing contractor.

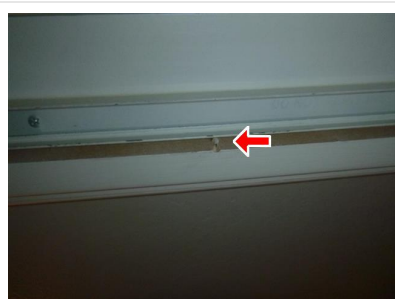
8.1 Item 4 (Picture)

(2) Possible presence of wood eating organisms at the hall linen closet. Advise a full evaluation by a qualified pest control expert.

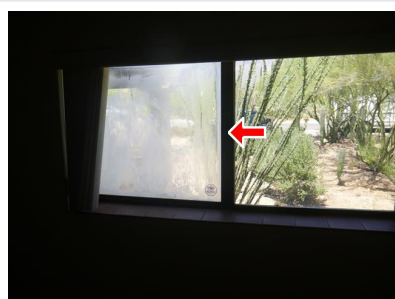
8.5 Item 1 (Picture)

Dual glazed window seals are compromised at the front and side bedrooms. Due to different temperature and lighting conditions there may be other compromised seals. This is largely considered a cosmetic concern. It is recommended that all windows be evaluated for failed seals and repair/replacement of windows, where needed, by a qualified window contractor.

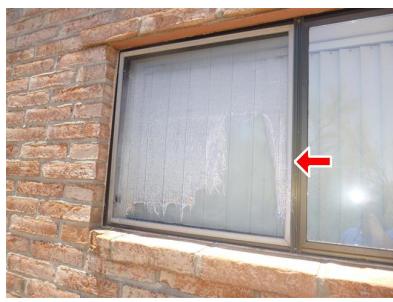
8.8 Item 1 (Picture)

(1) Worn / older window screens noted. Advise re-screening affected window screens.

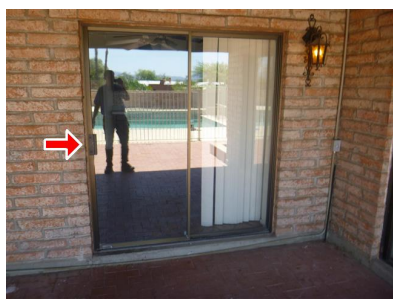
8.8 Item 2 (Picture)

(2) Missing / damaged screen door noted at rear patio. Advise obtaining and installing screen door.

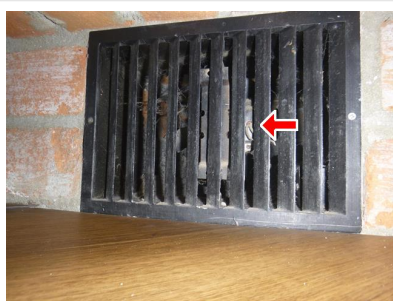
8.9 Item 1 (Picture)

(1) Powered fan for the fireplace did not turn on at the time of the inspection. Advise further evaluation of the fireplace fan with repairs as recommended by a qualified party.

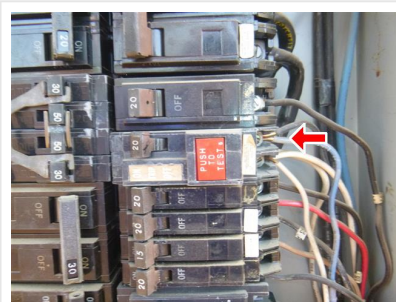
9.4 Item 1 (Picture)

Double tapped breaker noted. In general, only one wire should connect to any breaker, fuse or lug. Advise correction by an electrician.

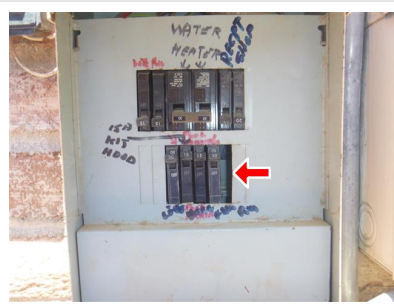
9.6 Item 1 (Picture)

Open knockout noted at the sub-panel electrical dead front panel. Advise installing approved filler.

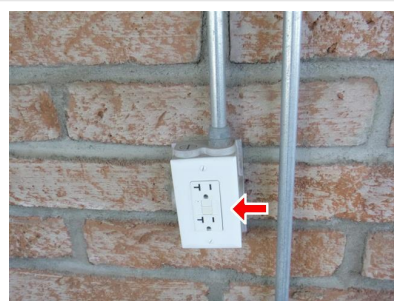
9.7 Item 1 (Picture)

(1) Missing exterior outlet cover at front porch outlet. Advise installing approved exterior outlet cover by a qualified person or electrician.

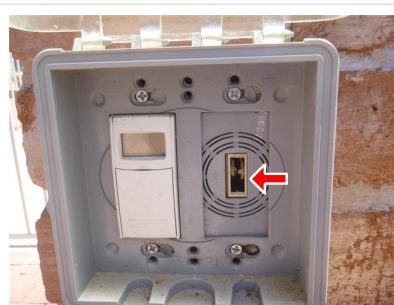
9.7 Item 2 (Picture)

(2) Damage switch noted at the rear yard. It is not functional, recommend replacement of the switch by a qualified person or electrician.

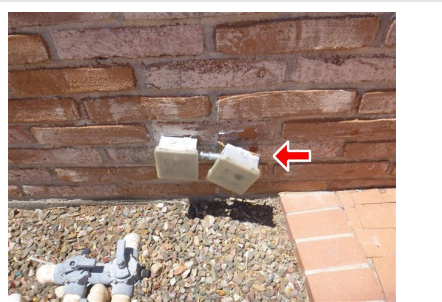
9.7 Item 3 (Picture)

(3) The switch boxes for the pool and spa controls are loose. Advise securing electrical boxes as needed by an electrician.

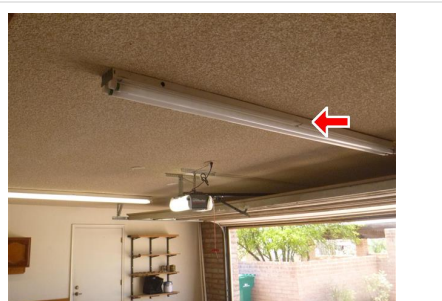
9.7 Item 4 (Picture)

(4) The light in the garage did not function when tested. The bulbs were flickering. Advise repairs as needed by an electrician or qualified party.

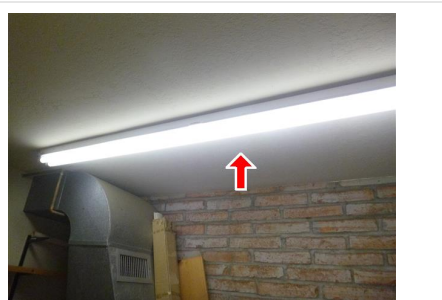
9.7 Item 5 (Picture)

(5) The fluorescent light in the garage storage room buzzes indicating the ballast may be going bad. Advise further evaluation / repair as needed by an electrician or qualified party.

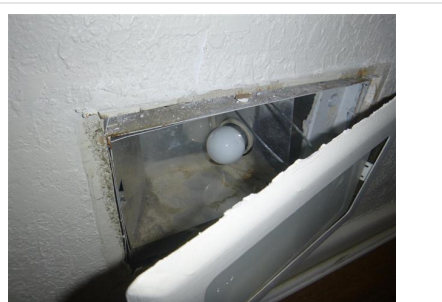
9.7 Item 6 (Picture)

(6) The kick light at the hallway did not appear to be controlled by a switch. Advise further evaluation / repairs as needed by an electrician. Light bulb was unscrewed.

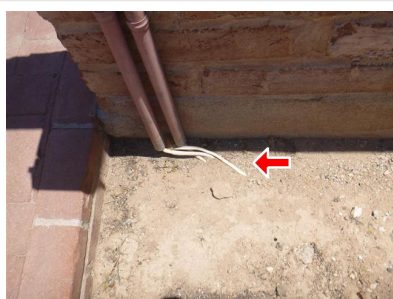
9.8 Item 2 (Picture)

(2) Exposed romex cable noted at rear yard. Also buried wiring is not UF burial wire as required for direct burial. Advise that all outside electrical cable be enclosed in conduit by qualified electrician.

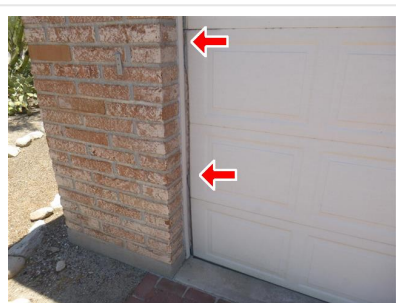
3.8 Item 3 (Picture)

(2) Loose / damaged garage door side seal noted. Advise securing garage door side seal to prevent possible pest and/or moisture intrusion.

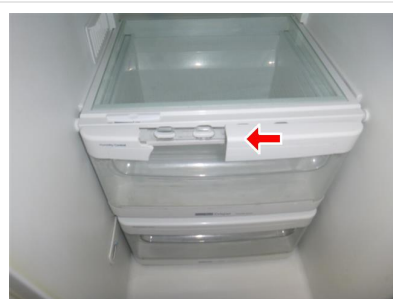
7.14 Item 4 (Picture)

(2) One of the drawers was damaged at time of inspection. Advise repairs as needed by a qualified party.

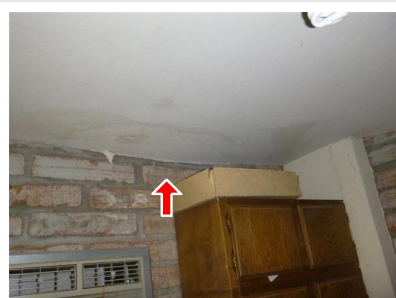
8.0 Item 1 (Picture)

(1) Moisture staining and drywall sagging noted at the garage closet ceiling in the corner. No moisture present at time of inspection. Advise further evaluation of roof at this area by a roofing contractor.

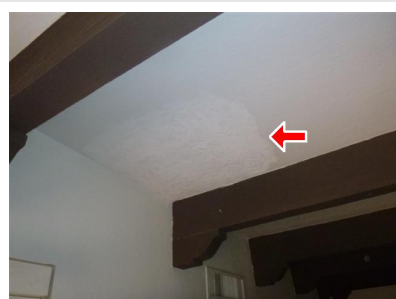
8.0 Item 2 (Picture)

(2) Un painted drywall repairs noted. Advise painting patches as needed.

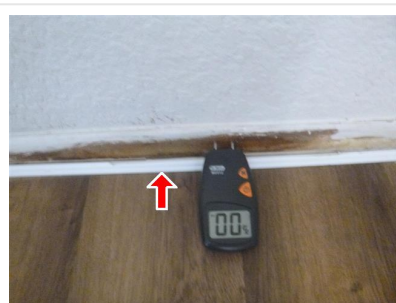
8.1 Item 1 (Picture)

(1) Moisture staining noted at the bedrooms and closets that are in contact with the exterior mechanical closet on the left side of the home. There was no moisture present at time of inspection. Advise further evaluation of roof at this area by a roofing contractor.

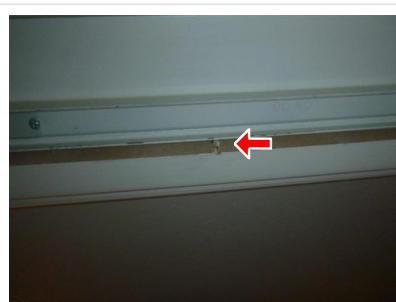
8.1 Item 4 (Picture)

(2) Possible presence of wood eating organisms at the hall linen closet. Advise a full evaluation by a qualified pest control expert.

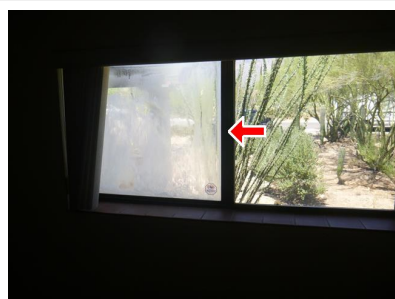
8.5 Item 1 (Picture)

Dual glazed window seals are compromised at the front and side bedrooms. Due to different temperature and lighting conditions there may be other compromised seals. This is largely considered a cosmetic concern. It is recommended that all windows be evaluated for failed seals and repair/replacement of windows, where needed, by a qualified window contractor.

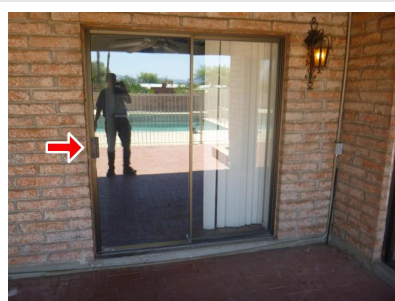
8.8 Item 2 (Picture)

(2) Missing / damaged screen door noted at rear patio. Advise obtaining and installing screen door.

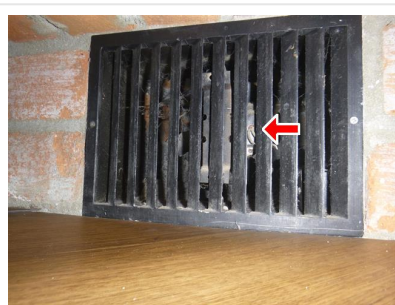
8.9 Item 1 (Picture)

(1) Powered fan for the fireplace did not turn on at the time of the inspection. Advise further evaluation of the fireplace fan with repairs as recommended by a qualified party.

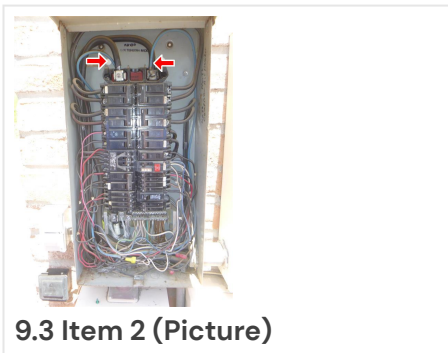
9.3 Item 2 (Picture)

(2) The main disconnect was bypassed with wires coming from the main incoming lines to the sub panel under the main distribution panel. There is no way to properly shut off the sub panel. Advise full evaluation / repairs as needed by an electrician.

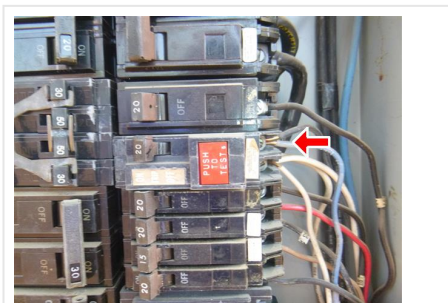
9.4 Item 1 (Picture)

Double tapped breaker noted. In general, only one wire should connect to any breaker, fuse or lug. Advise correction by an electrician.

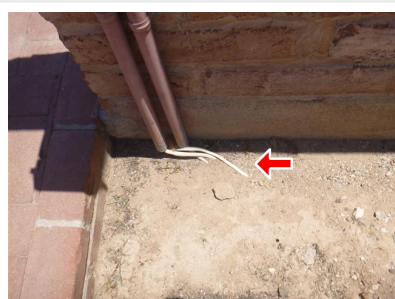
9.8 Item 2 (Picture)

(2) Exposed romex cable noted at rear yard. Also buried wiring is not UF burial wire as required for direct burial. Advise that all outside electrical cable be enclosed in conduit by qualified electrician.

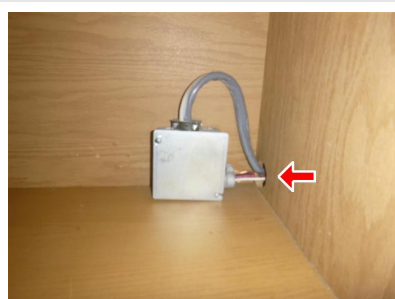
9.8 Item 5 (Picture)

(4) There are open splices noted at . Advise enclosing all exposed splices in a sealed junction box.

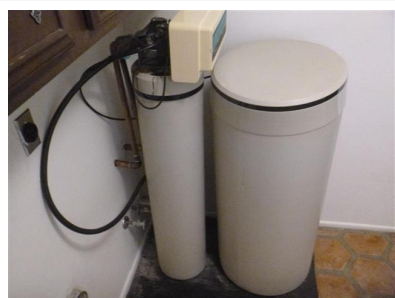
13.20 Item 1 (Picture)

(1) There is a water softening system located in the laundry room. These systems were only visually checked for leaks. Water quality was not tested. The unit appeared to be in bypass mode and there was no salt in system at time of inspection. Advise further evaluation of system viability from a water softening contractor.
