INSPECTION REPORT
2148 E Camino La Zorra
Tucson AZ 85718

INSPECTED BY
Robert Tackett
House and Home
LLC
73765

INSPECTION DATE
📅 7/8/2024
🕒 01:00 PM

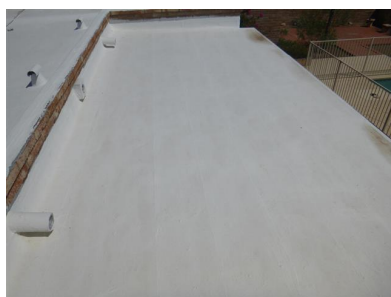
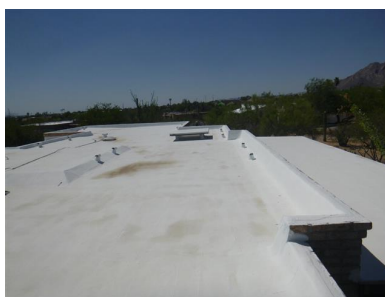
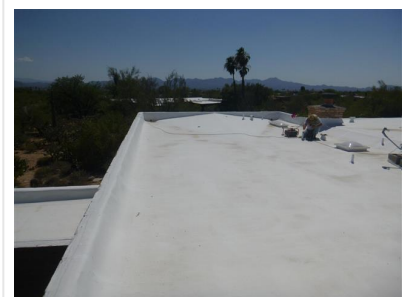
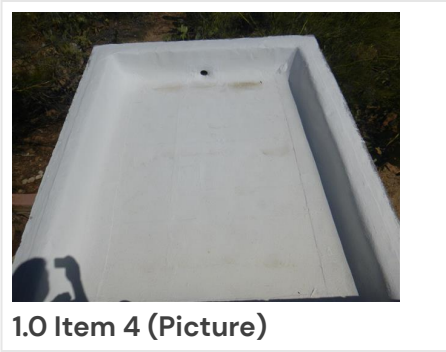
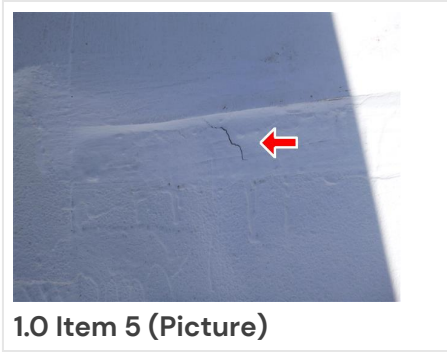
(1) Elastomeric coating is thinning and crazing / oxidized. Advise a full roof evaluation and repairs/re-coating as recommended by a roofing contractor.

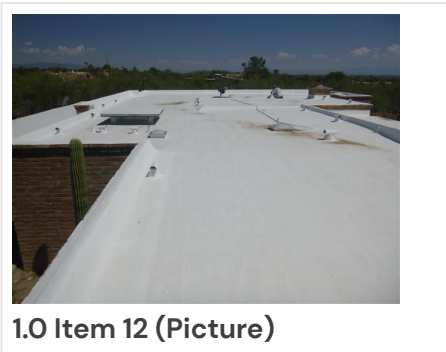
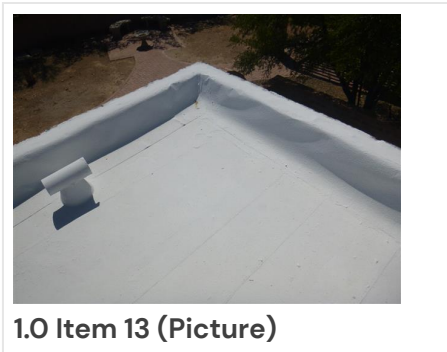
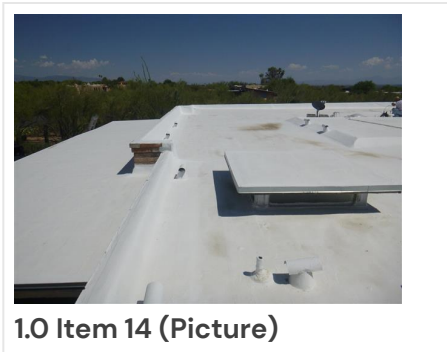
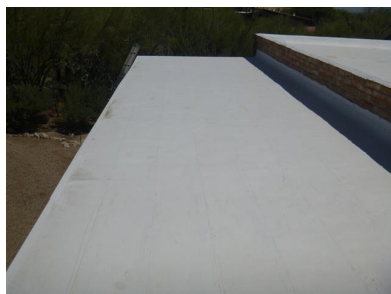
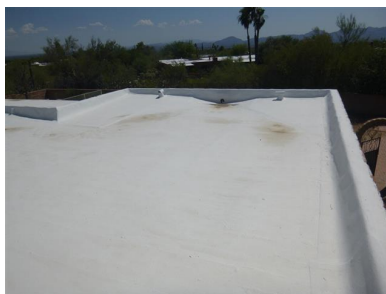
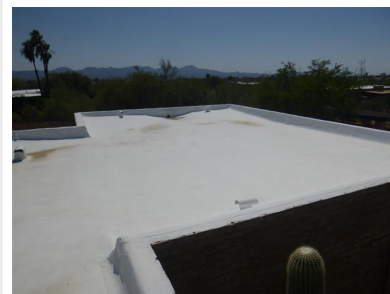
(3) Built up reflect roofs should be inspected every year looking for peeling reflective coating and cracking in the sealant especially around roof penetrations. It is recommended that the elastomeric coating on the roof be reapplied every 3 - 4 years. With proper maintenance a built up reflective roof can last indefinitely.

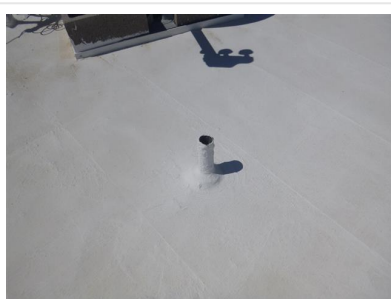
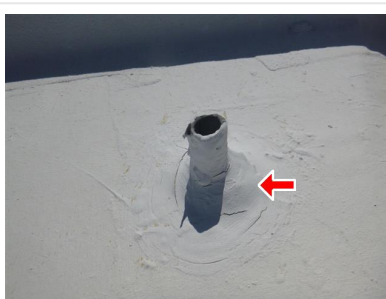
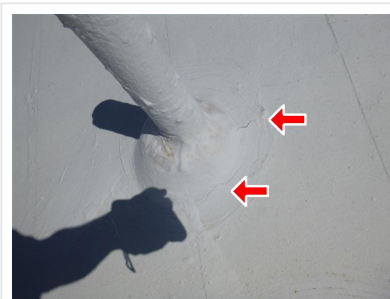
Roof penetrations are dried and cracked. Advise re-sealing roof penetrations by a qualified roofer.

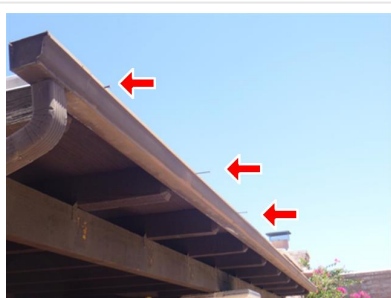
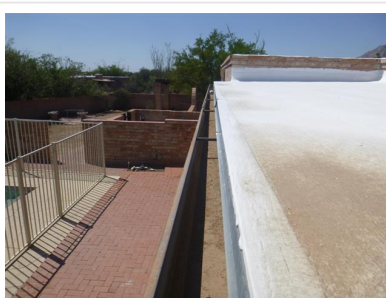
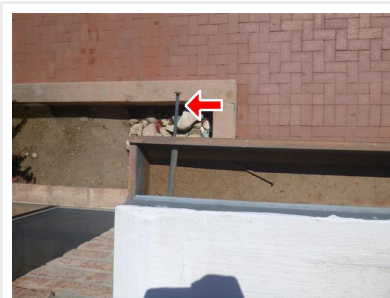
The gutters appeared to be in fair condition at time of inspection. Some of the nails have backed out. Advise securing gutters as needed.

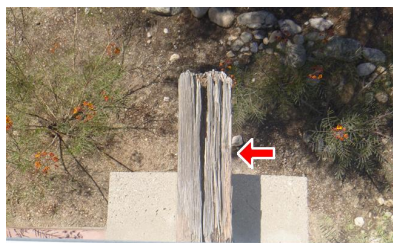
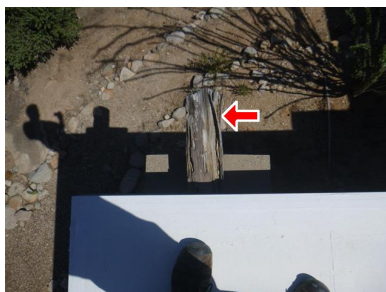
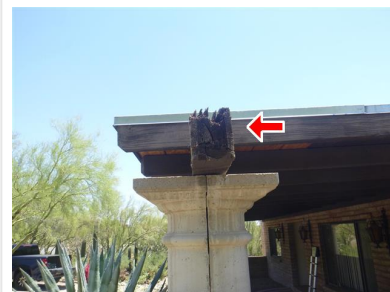
(1) Wood decay/damage noted at fascia and beam tails. Advise further evaluation of the area and the corresponding roof above (including any underlayment and/or flashings), with repairs as recommended by a roofing contractor.

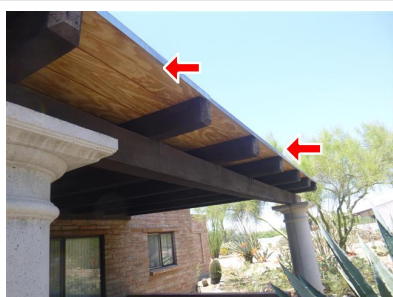
1.5 Item 4 (Picture)

(2) The roof decking at the front porch has been replaced but not painted. Advise painting exposed side of roof decking as needed.

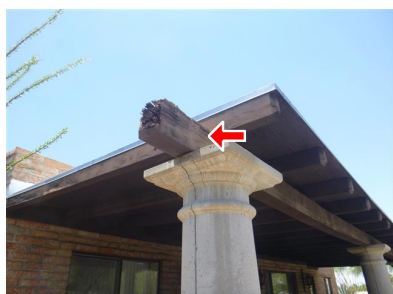
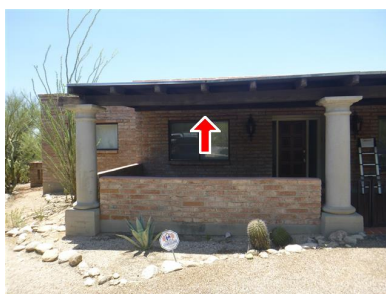
(3) The front porch left exposed beam is damaged and is sagging at the middle where there is a knot. Advise repair / replacement of damaged beam as needed.

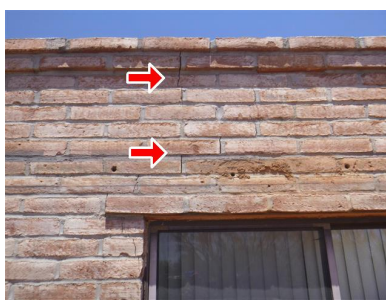
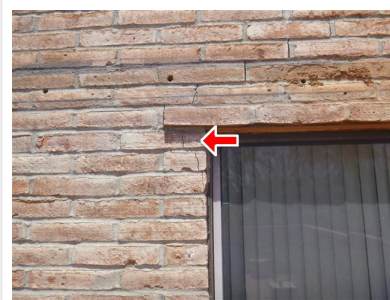
Fine cracking noted in brick exterior. Cracks are less than 3/16 " (about the width of a quarter) and with no displacement. These cracks are most likely due to foundation settlement and are not structural. Advise filling the cracks with mortar and monitoring for further movement.

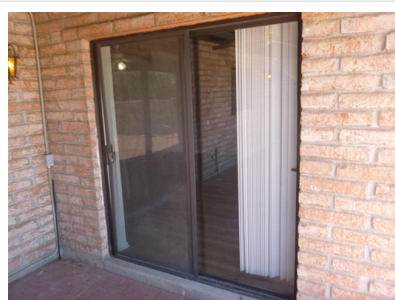
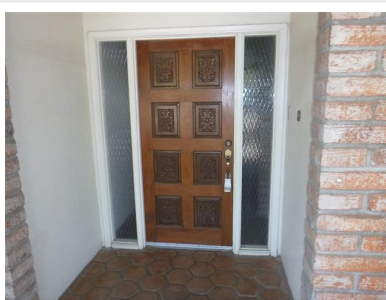
(1) The front entry door and rear sliding glass door functioned as intended when tested.

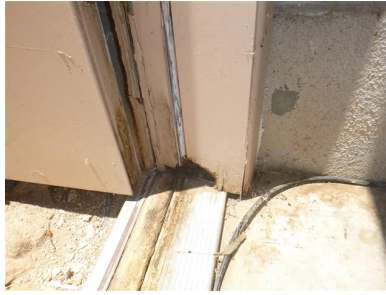
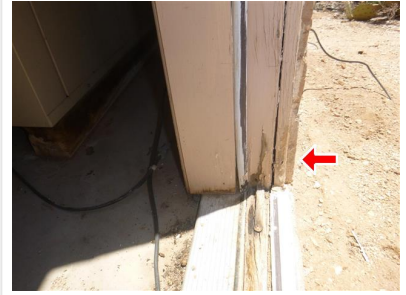
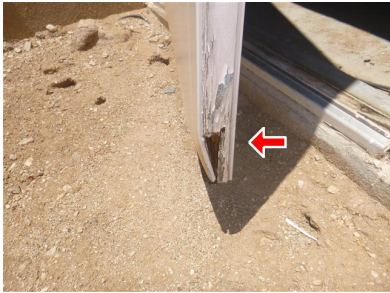
(3) Wood decay/damage noted at the exterior mechanical closet door threshold and door jamb. Advise further evaluation and repairs by a door company or qualified party.

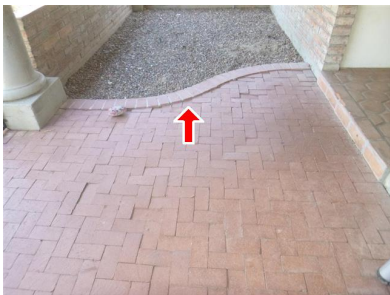
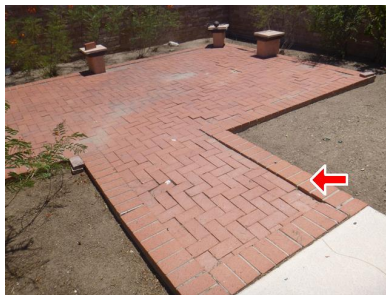
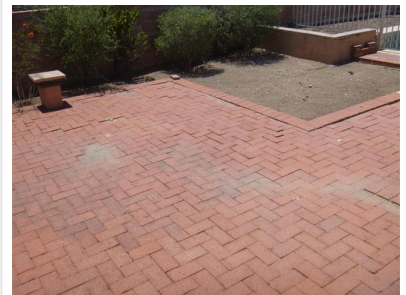
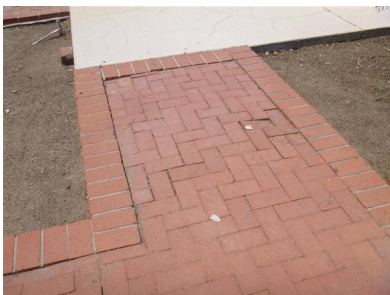
Tripping hazard noted at the front and rear patio paved walkway. A tripping hazard is present when a walkway is deflected upwards by 1/2 inch or more when you can reasonably expect that walkway to be even. Advise repairs as needed to address tripping hazard.

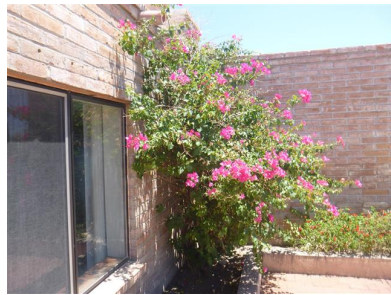
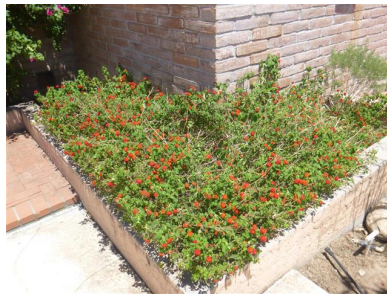
There are vines and shrubs in contact with the side of the home. This can trap moisture and could cause damage to stucco. Advise trimming vegetation away from home as needed.

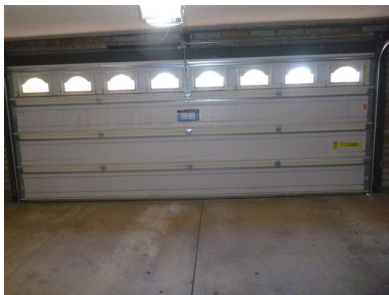
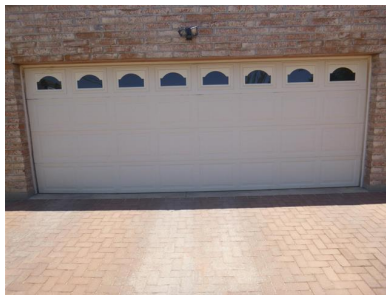
(1) The garage door functioned as intended when tested.

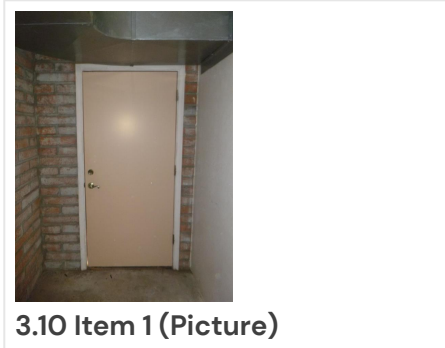
3.10 Item 1 (Picture)

The garage door-to-house does not self-close and latch. Advise installation of self-closing hinges or device to ensure proper self-closing and latching.

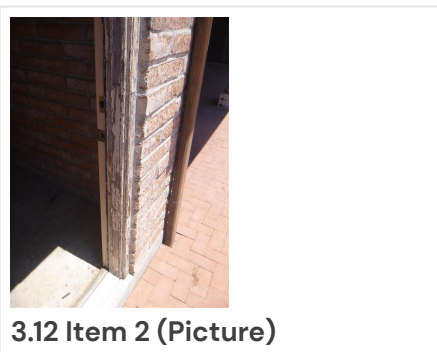
3.12 Item 2 (Picture)

Wood decay/damage noted at the threshold and door jamb. Advise further evaluation and repairs by a door company or qualified party.

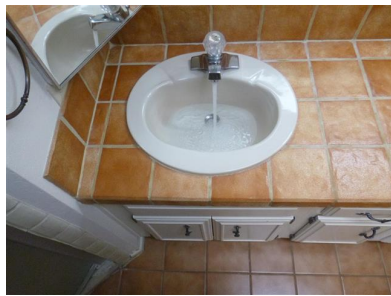
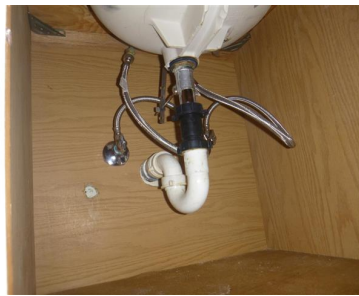
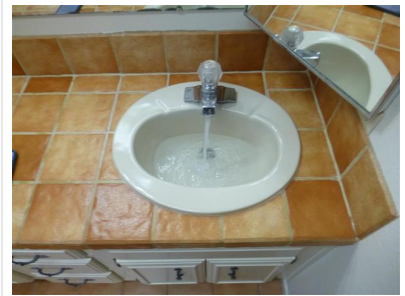
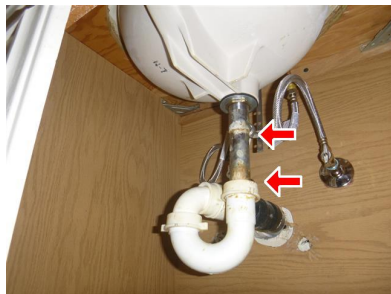
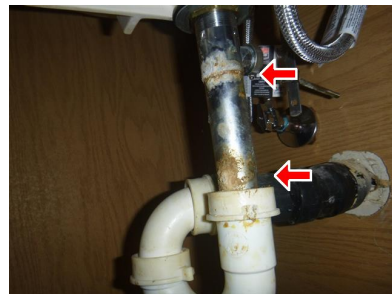
Excess calcification noted at the vanity sink drain connections. This may indicate a leak that has sealed itself. Not actively leaking at time of inspection. Consider further evaluation / repairs as needed by a plumber or qualified party.

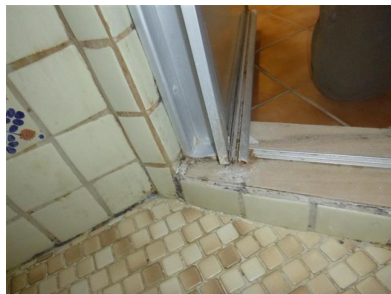
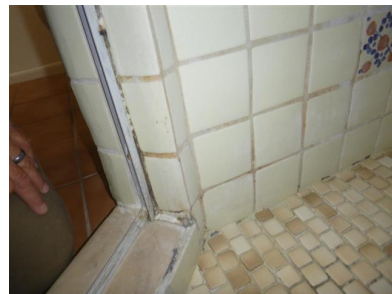
(1) Grout/caulking cracking noted at the stall shower enclosure floor and corners. There is also mold and mildew in the grouted areas. Advise re-grouting/sealing by a qualified party.

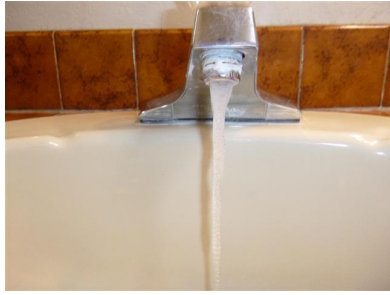
6.0.B Item 5 (Picture)

(2) Low flow noted at the left hall bath vanity faucet at both the HOT and COLD sides. Advise cleaning aerator. If situation does not improve, advise further evaluation by a qualified plumber.

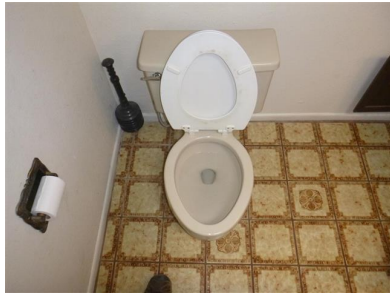
6.1.B Item 1 (Picture)

Toilet bowl is loose at the floor. No leaking during flushing. Advise re-tightening the bolts at the base of the toilet.

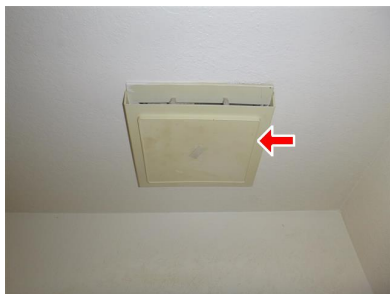
6.7.B Item 1 (Picture)

Ventilation fan was noisy during operation. Advise repairs by a qualified person or HVAC contractor.

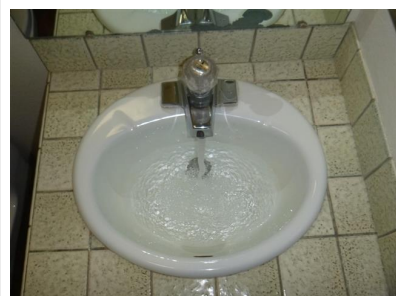
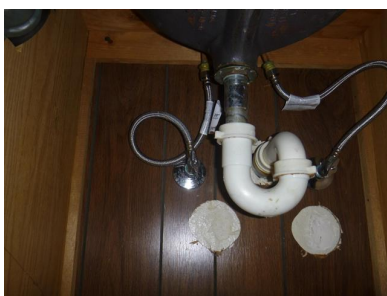
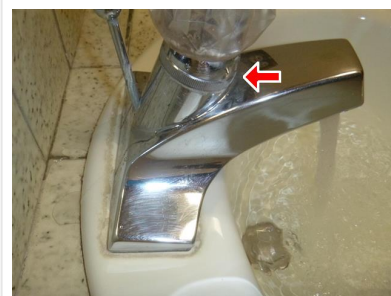
Leaking noted at the bathroom sink valve. Leaking is only occurring when the water is on and is leaking onto the countertop only. Advise repairs by a qualified person or plumber.

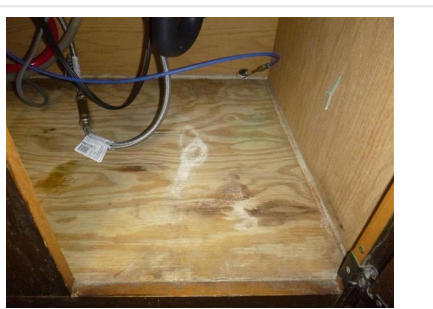
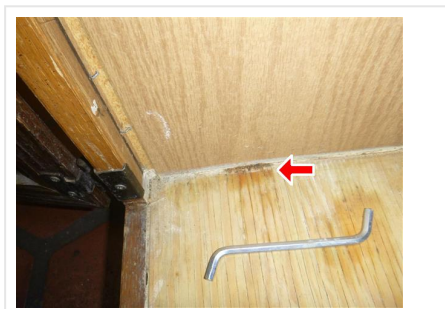
Water staining noted at the kitchen sink cabinet. No moisture or leaking noted at the time of the inspection but signs of black mold like material. Advise further evaluation by a mold inspector and monitoring area for a worsening in condition and repairs as needed.

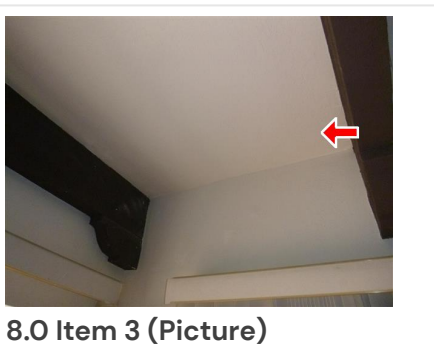
8.0 Item 3 (Picture)

(2) Un painted drywall repairs noted. Advise painting patches as needed.

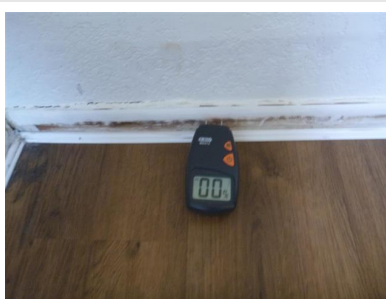
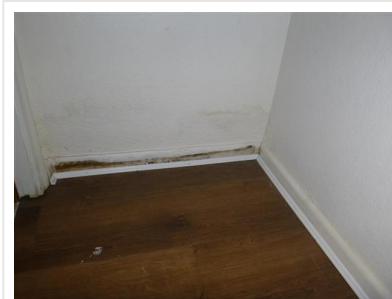
(1) Moisture staining noted at the bedrooms and closets that are in contact with the exterior mechanical closet on the left side of the home. There was no moisture present at time of inspection. Advise further evaluation of roof at this area by a roofing contractor.

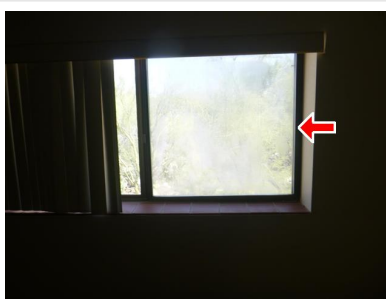
8.5 Item 2 (Picture)

Dual glazed window seals are compromised at the front and side bedrooms. Due to different temperature and lighting conditions there may be other compromised seals. This is largely considered a cosmetic concern. It is recommended that all windows be evaluated for failed seals and repair/replacement of windows, where needed, by a qualified window contractor.

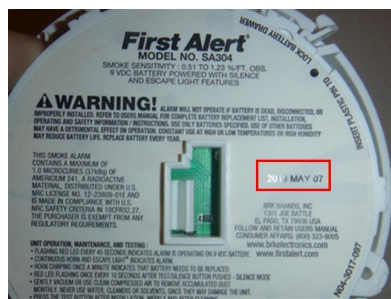
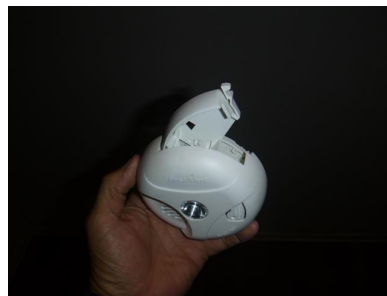
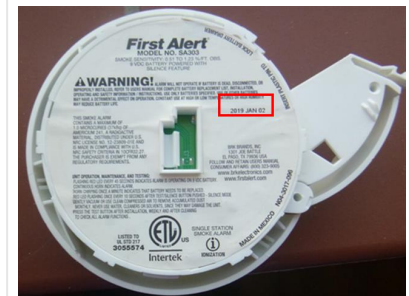
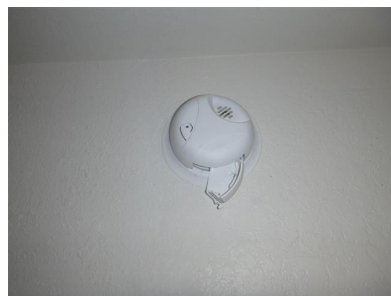
(1) Smoke detectors from 2019 but missing batteries at the 3 guest bedrooms. Advise replacement of detector(s) when they reach 10 years old or as needed and the installation of batteries as needed.

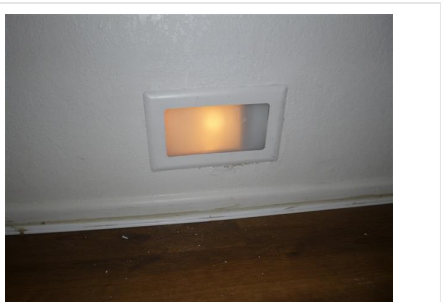
9.7 Item 7 (Picture)

(6) The kick light at the hallway did not appear to be controlled by a switch. Advise further evaluation / repairs as needed by an electrician. Light bulb was unscrewed.

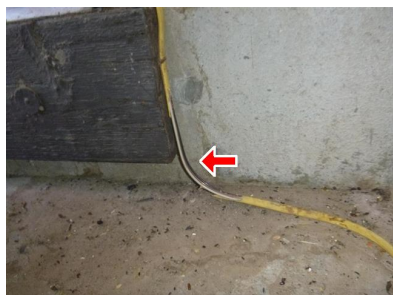
9.8 Item 1 (Picture)

(1) Exposed romex cable noted at exterior mechanical closet. The wiring in the closet has been damaged by rodents. Advise that all outside electrical cable be enclosed in conduit by qualified electrician.

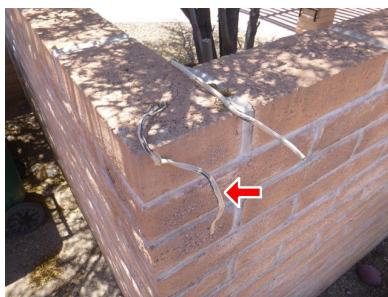
9.8 Item 4 (Picture)

(3) There are open splices noted at rear wall column for possible post light. Advise enclosing all exposed splices in a sealed junction box.

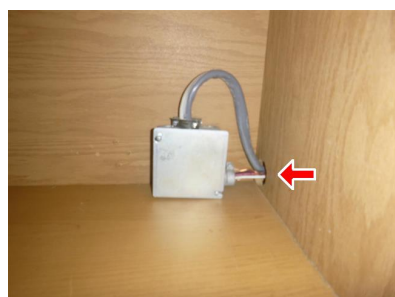
9.8 Item 5 (Picture)

(4) There are open splices noted at . Advise enclosing all exposed splices in a sealed junction box.

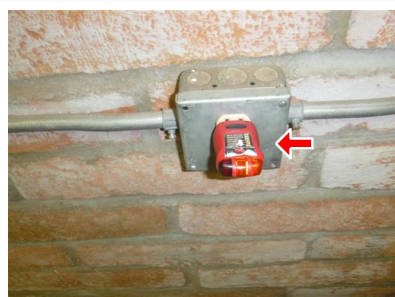
9.9 Item 1 (Picture)

(2) No GFCI protection at the garage outlets. Required since 1978. Advise installation of GFCI protection at the garage outlets by a qualified person or electrician.

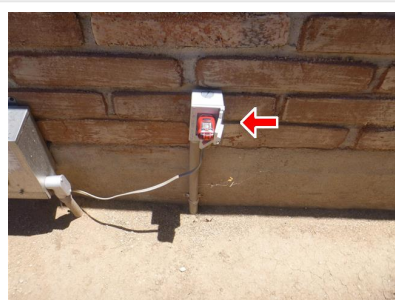
9.9 Item 2 (Picture)

(3) No GFCI protection at the exterior outlets. Required since 1973. Advise installation of GFCI protection at the exterior outlets by a qualified person or electrician.

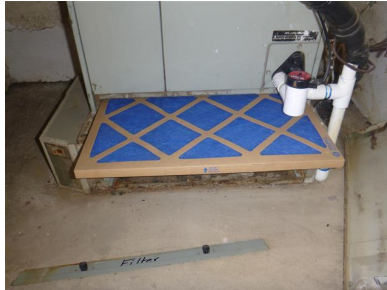
10.4.A Item 1 (Picture)

(2) The unit has a honeywell electronic filter system that is older and not in use at time of inspection.

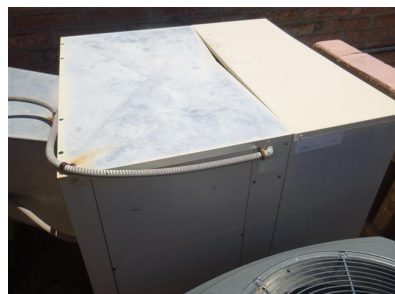
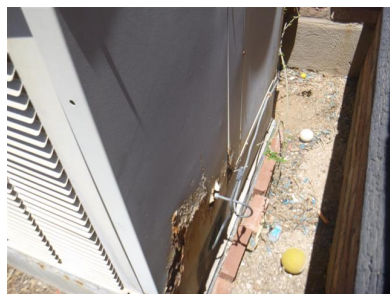
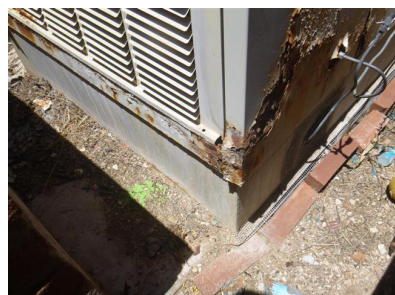
The evaporative cooler was winterized and not connected to water at time of inspection. It was not operated. There is some damage and rusting to the cooler shell. Advise further evaluation by a qualified party prior to use.

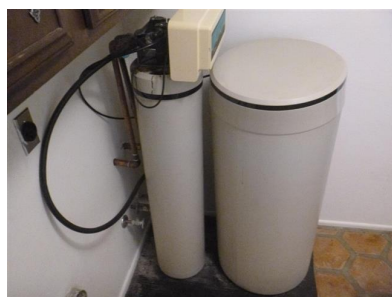
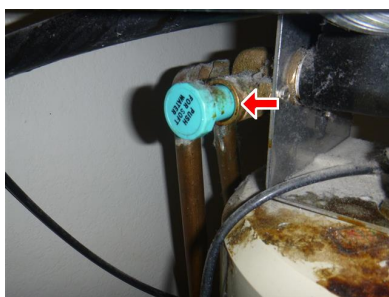
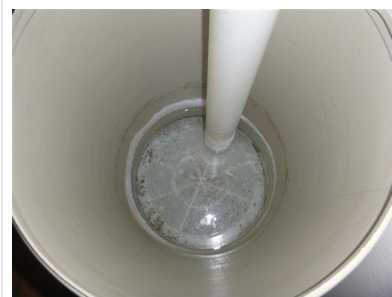
(1) There is a water softening system located in the laundry room. These systems were only visually checked for leaks. Water quality was not tested. The unit appeared to be in bypass mode and there was no salt in system at time of inspection. Advise further evaluation of system viability from a water softening contractor.

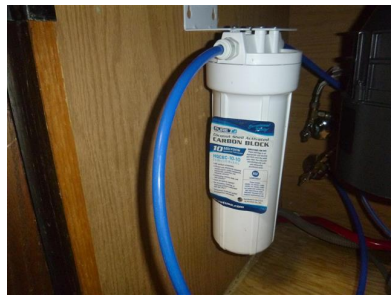
13.20 Item 4 (Picture)

(2) There is a cartridge water filtration system under the kitchen sink. This system was only visually inspected for leaks. The spout leaks when water is dispensed. The water quality was not tested. Advise repairs as needed by a qualified party.

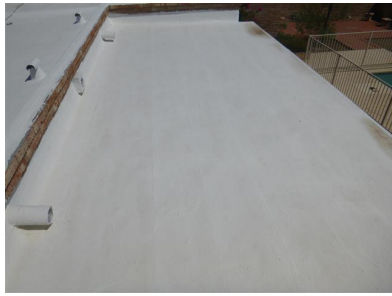
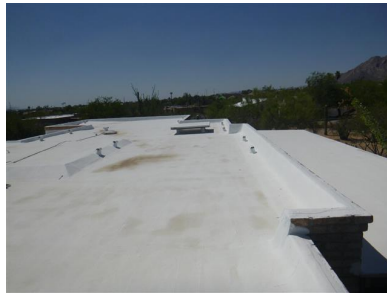
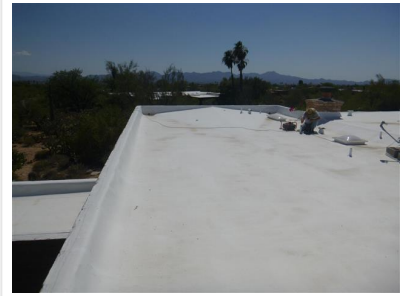
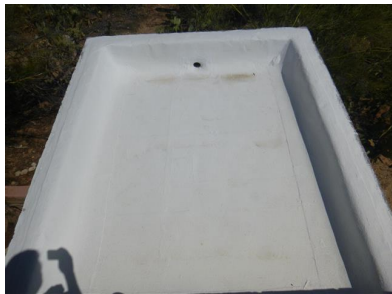
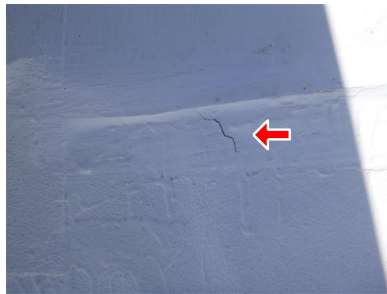
(1) Elastomeric coating is thinning and crazing / oxidized. Advise a full roof evaluation and repairs/re-coating as recommended by a roofing contractor.

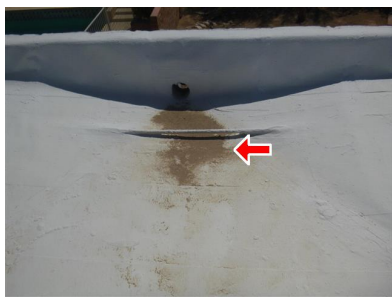
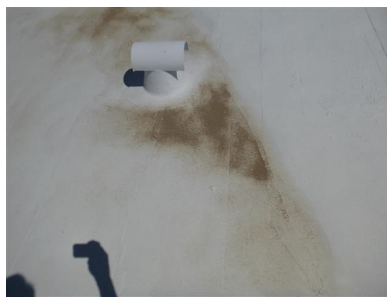
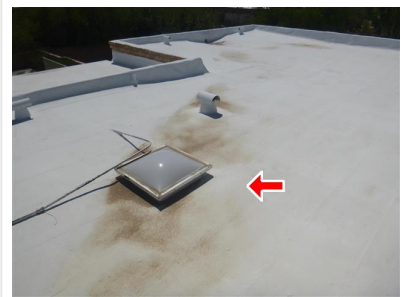
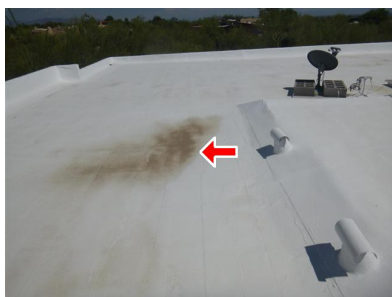
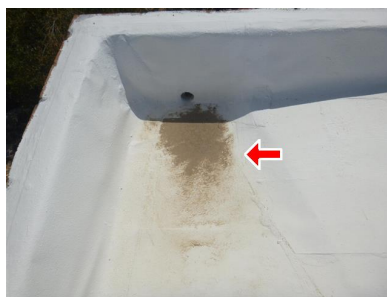
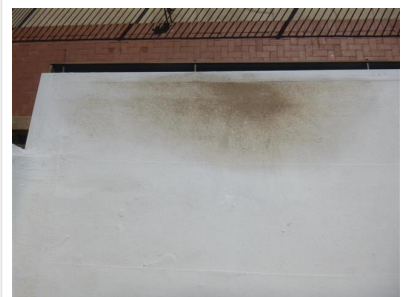
(2) Areas of ponding on the roof. Advise building-up areas to allow for proper drainage by a roofing contractor.

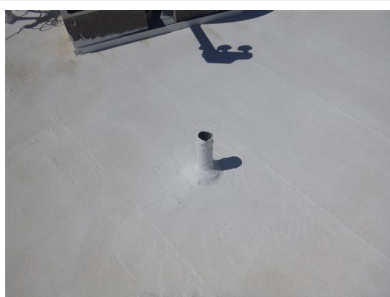
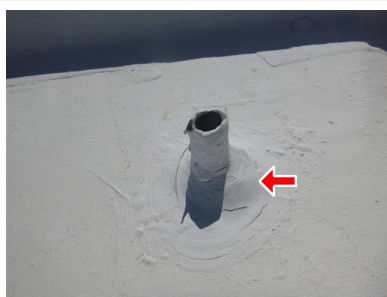
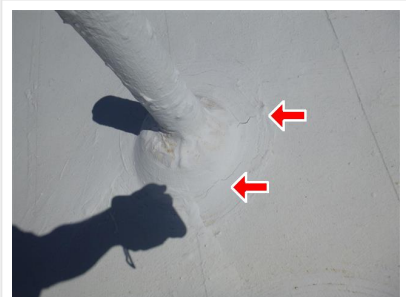
Roof penetrations are dried and cracked. Advise re-sealing roof penetrations by a qualified roofer.

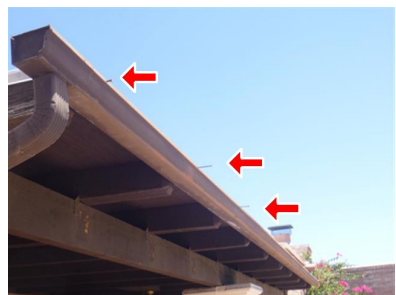
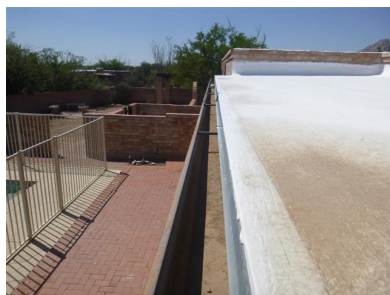
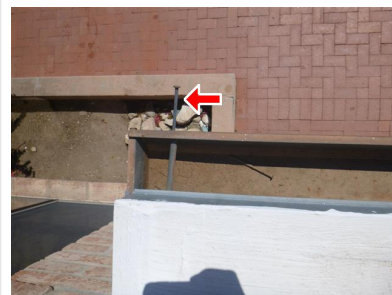
The gutters appeared to be in fair condition at time of inspection. Some of the nails have backed out. Advise securing gutters as needed.

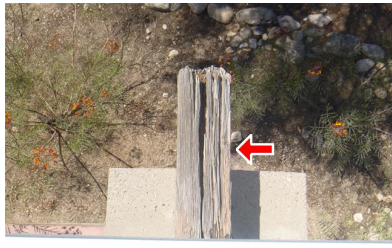
1.5 Item 1 (Picture)

(1) Wood decay/damage noted at fascia and beam tails. Advise further evaluation of the area and the corresponding roof above (including any underlayment and/or flashings), with repairs as recommended by a roofing contractor.

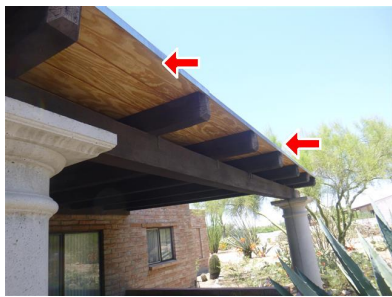
1.5 Item 4 (Picture)

(2) The roof decking at the front porch has been replaced but not painted. Advise painting exposed side of roof decking as needed.

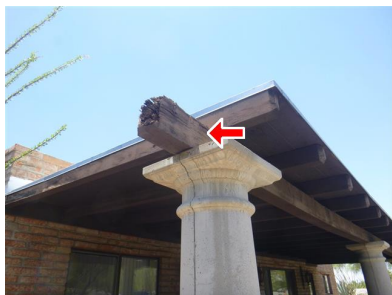
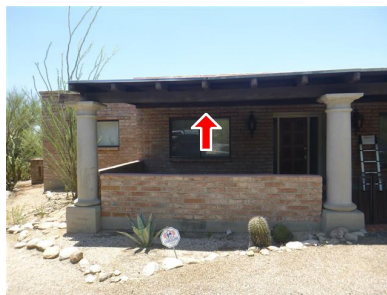
1.5 Item 5 (Picture)

(3) The front porch left exposed beam is damaged and is sagging at the middle where there is a knot. Advise repair / replacement of damaged beam as needed.

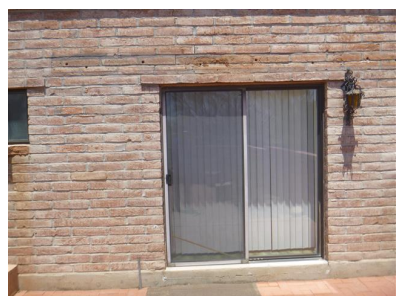
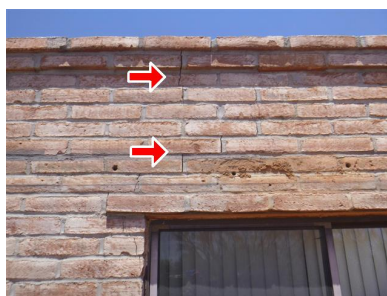
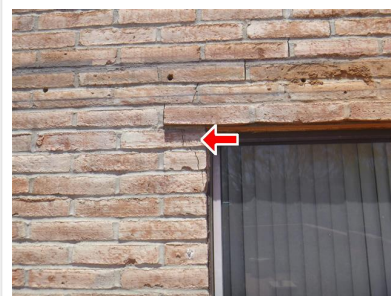
Fine cracking noted in brick exterior. Cracks are less than 3/16 " (about the width of a quarter) and with no displacement. These cracks are most likely due to foundation settlement and are not structural. Advise filling the cracks with mortar and monitoring for further movement.

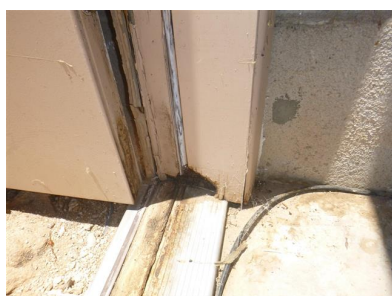
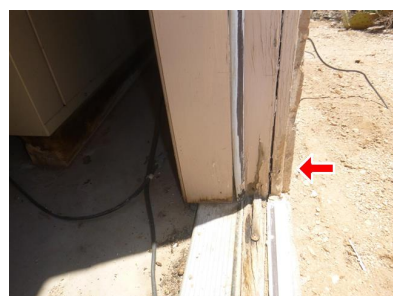
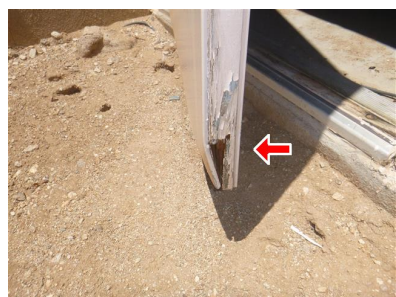
(3) Wood decay/damage noted at the exterior mechanical closet door threshold and door jamb. Advise further evaluation and repairs by a door company or qualified party.

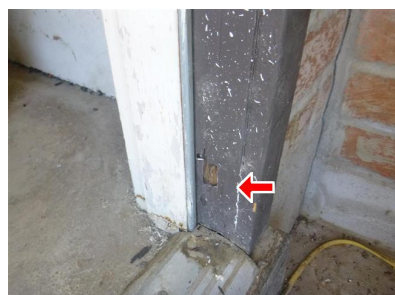
2.7 Item 1 (Picture)

(1) Possible presence of wood eating organisms. Damage noted at the exterior closet door jamb. Advise a full evaluation by a qualified pest control expert.

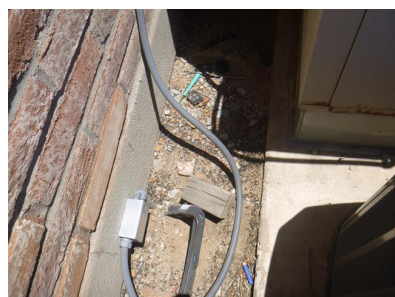
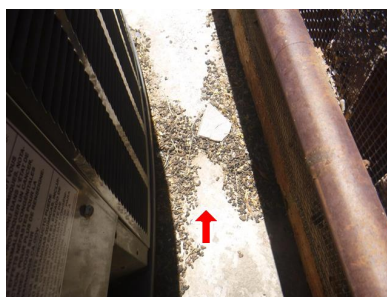
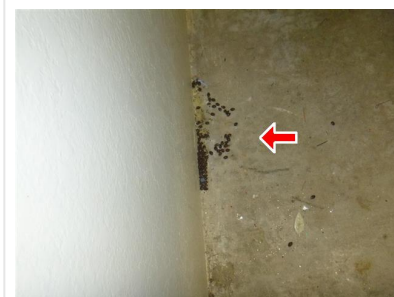
(2) Rodent droppings around the mechanical equipment. Advise further evaluation / remediation of rodents and droppings as needed.

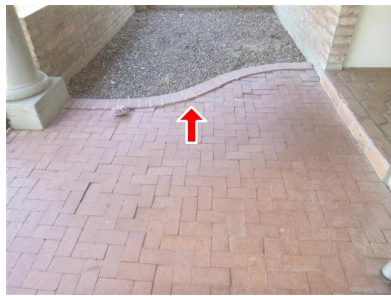
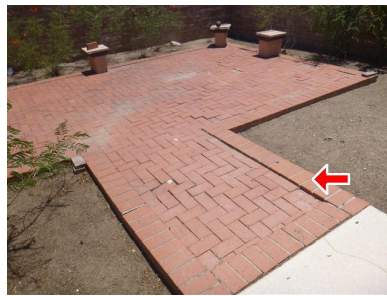
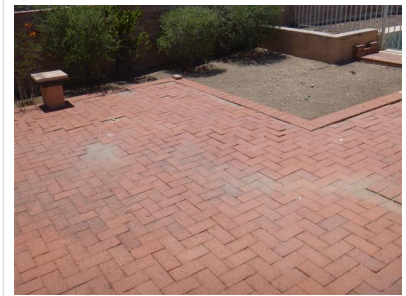
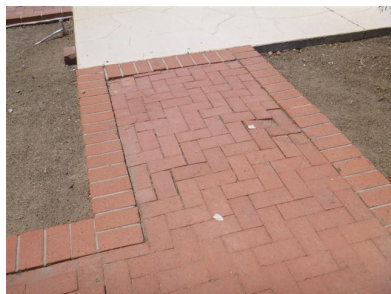
Tripping hazard noted at the front and rear patio paved walkway. A tripping hazard is present when a walkway is deflected upwards by 1/2 inch or more when you can reasonably expect that walkway to be even. Advise repairs as needed to address tripping hazard.

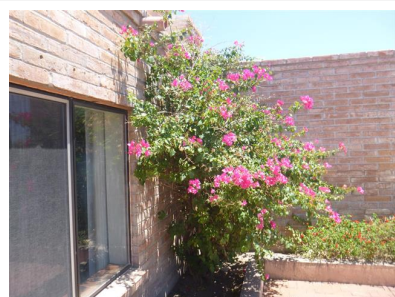
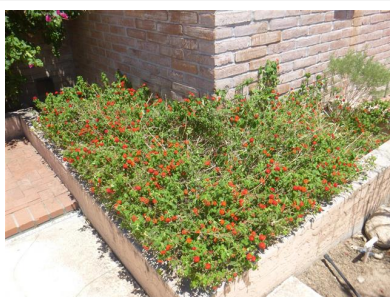
There are vines and shrubs in contact with the side of the home. This can trap moisture and could cause damage to stucco. Advise trimming vegetation away from home as needed.

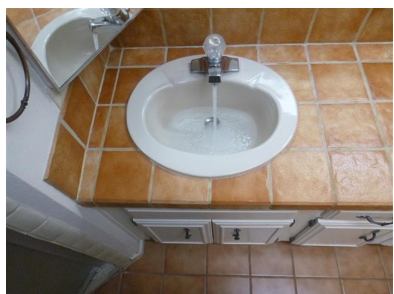
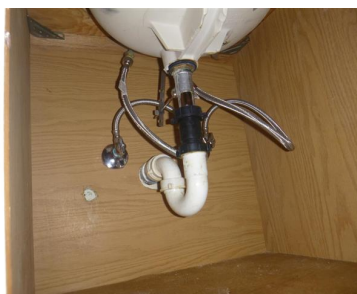
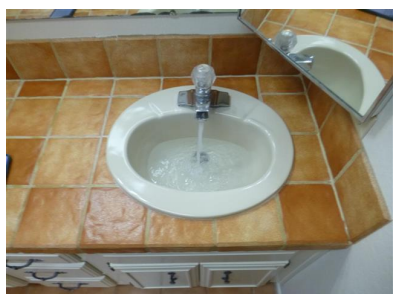
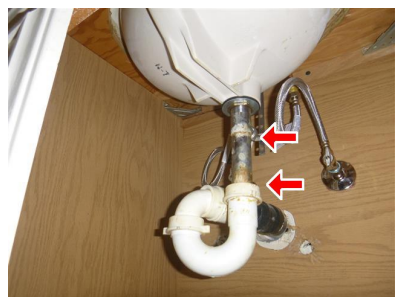
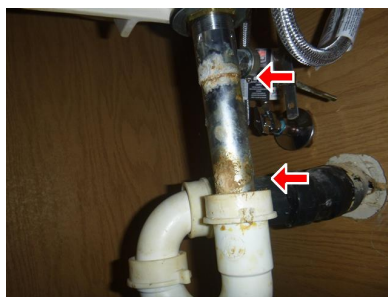
Excess calcification noted at the vanity sink drain connections. This may indicate a leak that has sealed itself. Not actively leaking at time of inspection. Consider further evaluation / repairs as needed by a plumber or qualified party.

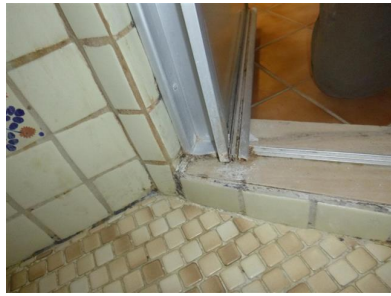
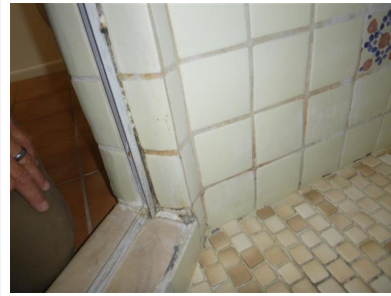
(1) Grout/caulking cracking noted at the stall shower enclosure floor and corners. There is also mold and mildew in the grouted areas. Advise re-grouting/sealing by a qualified party.

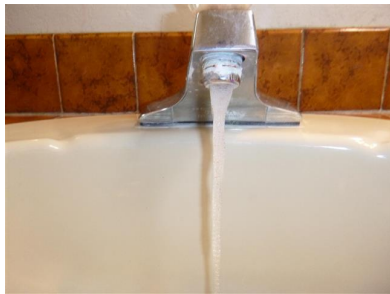
6.0.B Item 5 (Picture)

(2) Low flow noted at the left hall bath vanity faucet at both the HOT and COLD sides. Advise cleaning aerator. If situation does not improve, advise further evaluation by a qualified plumber.

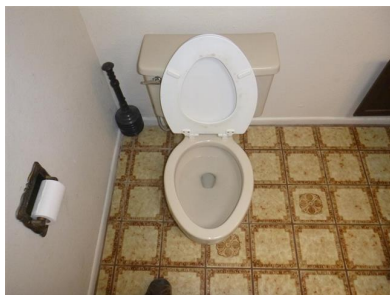
6.1.B Item 1 (Picture)

Toilet bowl is loose at the floor. No leaking during flushing. Advise re-tightening the bolts at the base of the toilet.

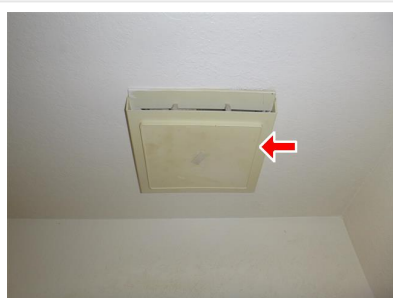
6.7.B Item 1 (Picture)

Ventilation fan was noisy during operation. Advise repairs by a qualified person or HVAC contractor.

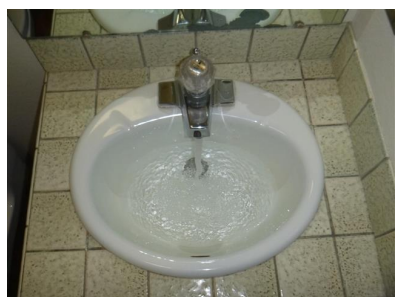
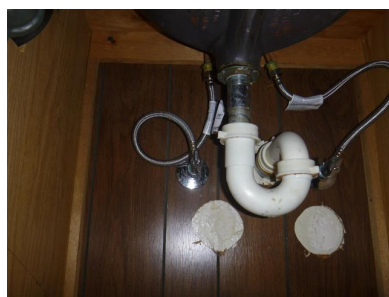
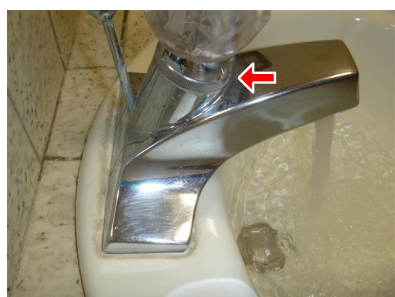
Leaking noted at the bathroom sink valve. Leaking is only occurring when the water is on and is leaking onto the countertop only. Advise repairs by a qualified person or plumber.

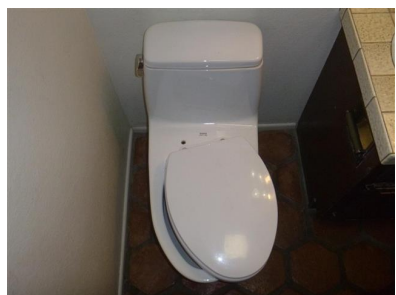
6.1.C Item 1 (Picture)

The toilet functioned as intended when tested but has a loose toilet seat. Advise securing seat as needed by a qualified party.

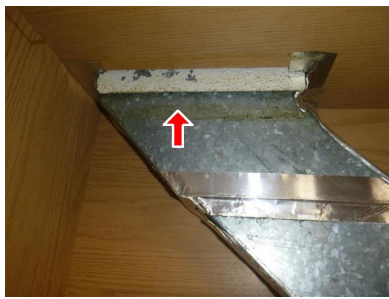
7.11 Item 2 (Picture)

(2) Air leaking into the cabinet from the duct for the exhaust hood. Advise repairs as needed to seal duct.

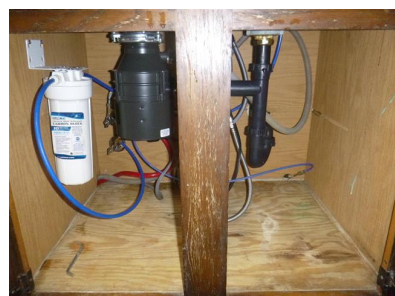
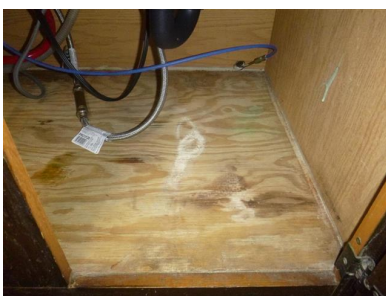
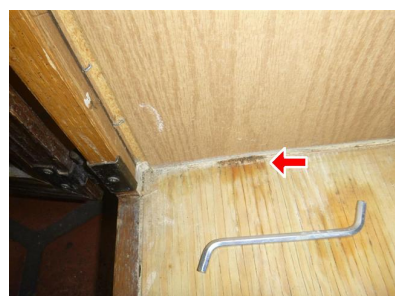
Water staining noted at the kitchen sink cabinet. No moisture or leaking noted at the time of the inspection but signs of black mold like material. Advise further evaluation by a mold inspector and monitoring area for a worsening in condition and repairs as needed.

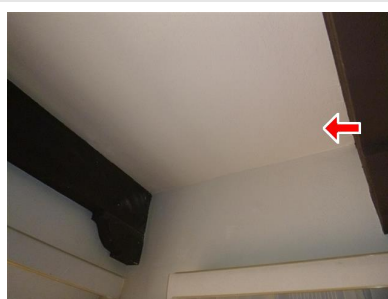
8.0 Item 3 (Picture)

(2) Un painted drywall repairs noted. Advise painting patches as needed.

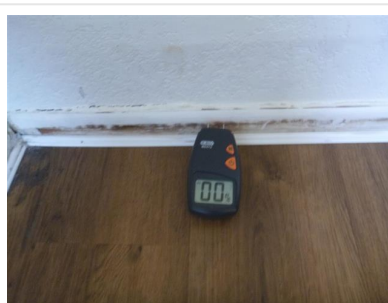
8.1 Item 2 (Picture)

(1) Moisture staining noted at the bedrooms and closets that are in contact with the exterior mechanical closet on the left side of the home. There was no moisture present at time of inspection. Advise further evaluation of roof at this area by a roofing contractor.

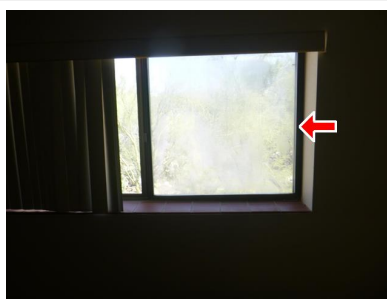
8.5 Item 2 (Picture)

Dual glazed window seals are compromised at the front and side bedrooms. Due to different temperature and lighting conditions there may be other compromised seals. This is largely considered a cosmetic concern. It is recommended that all windows be evaluated for failed seals and repair/replacement of windows, where needed, by a qualified window contractor.

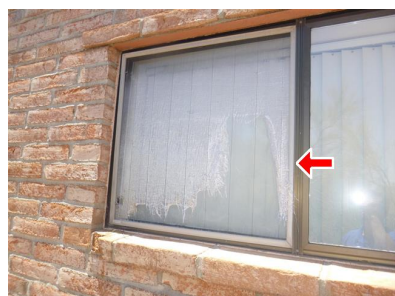
8.8 Item 1 (Picture)

(1) Worn / older window screens noted. Advise re-screening affected window screens.

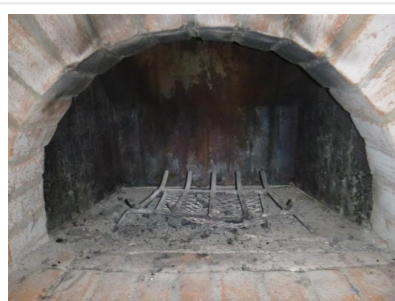
8.9 Item 2 (Picture)

(2) The wood burning fireplace appeared to be in good condition when inspected.

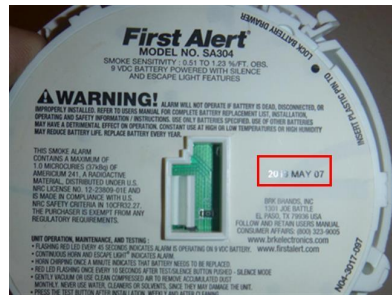
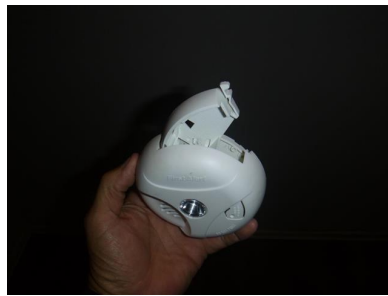
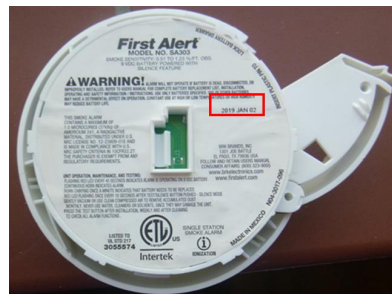
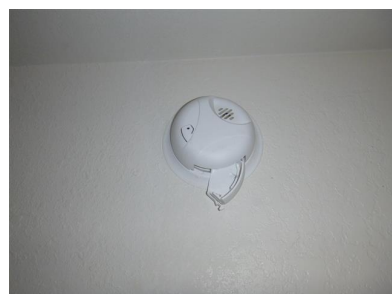
(1) Smoke detectors from 2019 but missing batteries at the 3 guest bedrooms. Advise replacement of detector(s) when they reach 10 years old or as needed and the installation of batteries as needed.

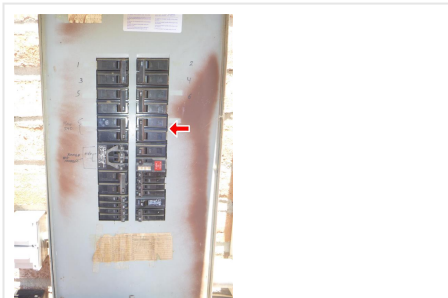
9.3 Item 1 (Picture)

(1) The main electrical disconnect is located in the electrical panel.

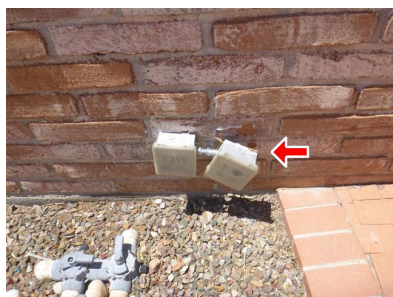
9.7 Item 3 (Picture)

(3) The switch boxes for the pool and spa controls are loose. Advise securing electrical boxes as needed by an electrician.

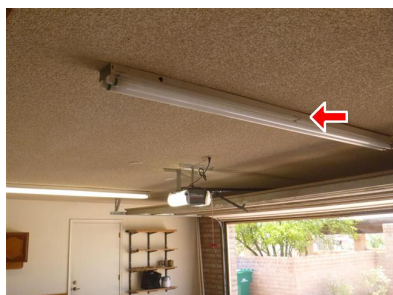
9.7 Item 4 (Picture)

(4) The light in the garage did not function when tested. The bulbs were flickering. Advise repairs as needed by an electrician or qualified party.

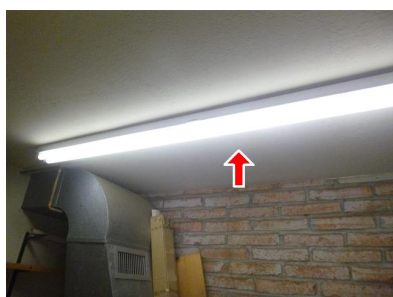
9.7 Item 5 (Picture)

(5) The fluorescent light in the garage storage room buzzes indicating the ballast may be going bad. Advise further evaluation / repair as needed by an electrician or qualified party.

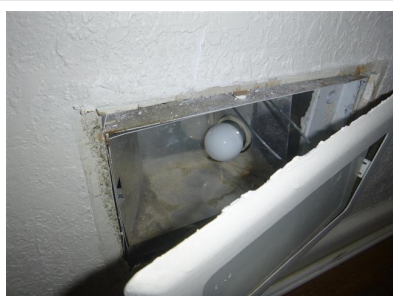
9.7 Item 6 (Picture)

(6) The kick light at the hallway did not appear to be controlled by a switch. Advise further evaluation / repairs as needed by an electrician. Light bulb was unscrewed.

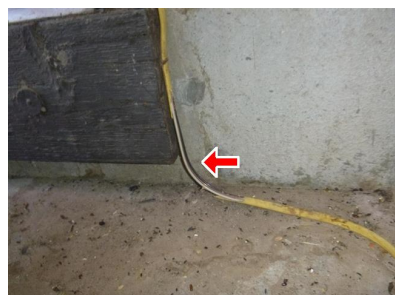
9.8 Item 1 (Picture)

(1) Exposed romex cable noted at exterior mechanical closet. The wiring in the closet has been damaged by rodents. Advise that all outside electrical cable be enclosed in conduit by qualified electrician.

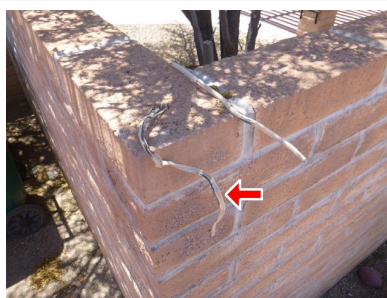
9.8 Item 4 (Picture)

(3) There are open splices noted at rear wall column for possible post light. Advise enclosing all exposed splices in a sealed junction box.

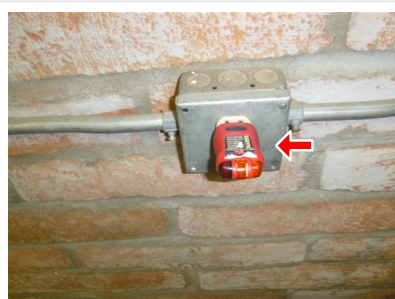
9.9 Item 1 (Picture)

(2) No GFCI protection at the garage outlets. Required since 1978. Advise installation of GFCI protection at the garage outlets by a qualified person or electrician.

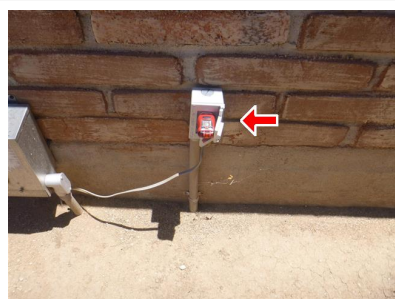
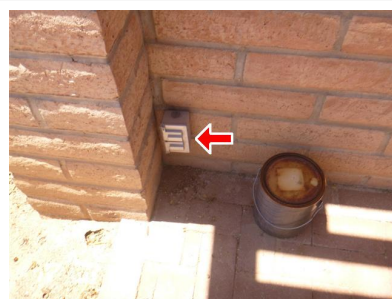
(3) No GFCI protection at the exterior outlets. Required since 1973. Advise installation of GFCI protection at the exterior outlets by a qualified person or electrician.

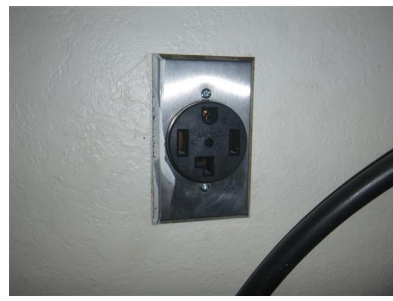
9.11 Item 1 (Picture)

The 220 Volt dryer receptacle requires a 4 prong plug.

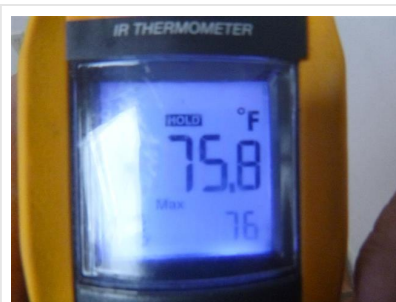
Temperature differential between supply and return registers averages 23 degrees fahrenheit. A temperature differential between 18 - 26 degrees fahrenheit is considered satisfactory. Our inspection of both the cooling and heating systems are not as intensive as provided by a qualified HVAC technician who test individual components and efficiency.

10.0.A Item 1 (Picture)
Return Air Temp

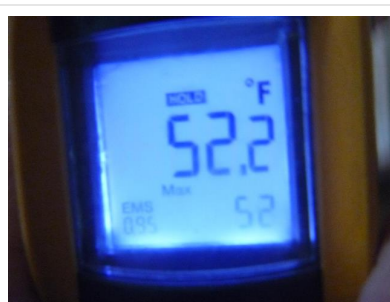
10.0.A Item 2 (Picture)
Supply Air Temp

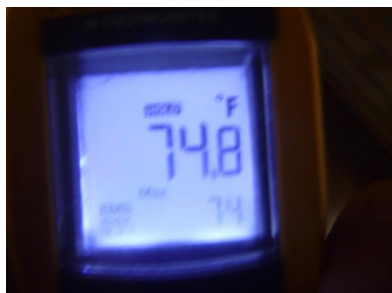
Temperature differential between supply and return registers averages 24 degrees fahrenheit. A temperature differential between 18 - 26 degrees fahrenheit is considered satisfactory. Our inspection of both the cooling and heating systems are not as intensive as provided by a qualified HVAC technician who test individual components and efficiency.

10.0.B Item 1 (Picture)
Return Air Temp

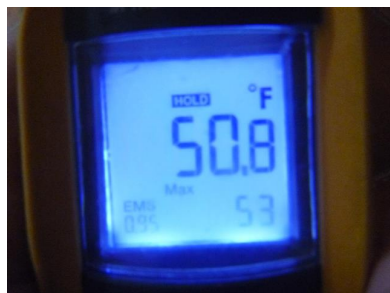
10.0.B Item 2 (Picture)
Supply Air Temp
