INSPECTION REPORT
2148 E Camino La Zorra
Tucson AZ 85718

INSPECTED BY
Robert Tackett
House and Home
LLC
73765

INSPECTION DATE
📅 7/8/2024
🕒 01:00 PM

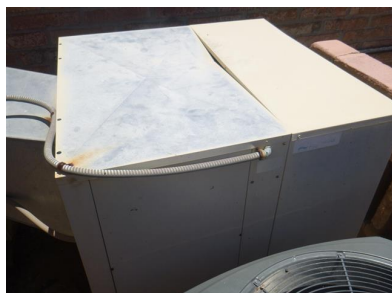
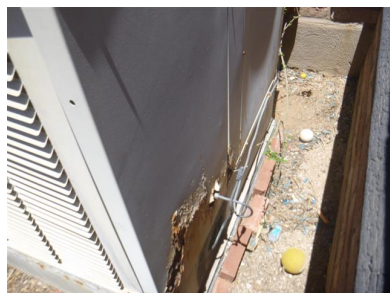
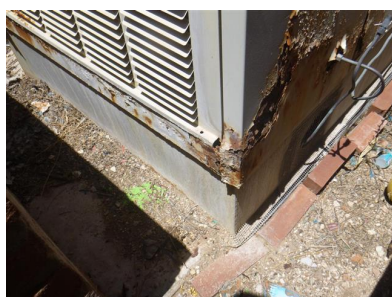
The evaporative cooler was winterized and not connected to water at time of inspection. It was not operated. There is some damage and rusting to the cooler shell. Advise further evaluation by a qualified party prior to use.

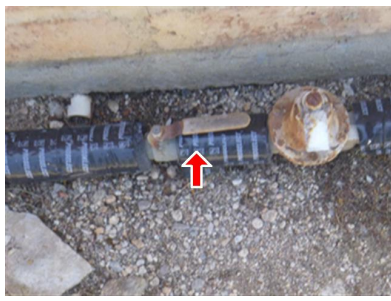
13.0 Item 1 (Picture)

The main water shut off valve is located on the front of the home.

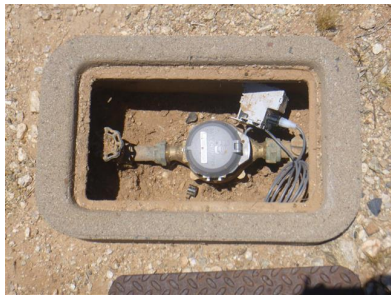
13.1 Item 1 (Picture)

The water meter box is clean and the meter and valves are accessible.

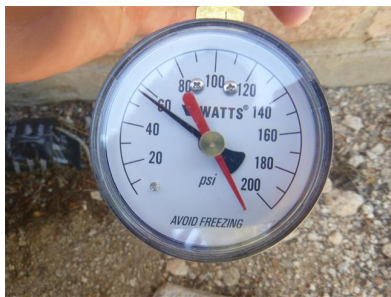
13.2 Item 1 (Picture)

Water pressure is 57 PSI. This is within the recommended range of 40 – 80 PSI. A pressure regulator was found on the piping where the water lines enter the house. Water pressure can be adjusted with the regulator as desired.

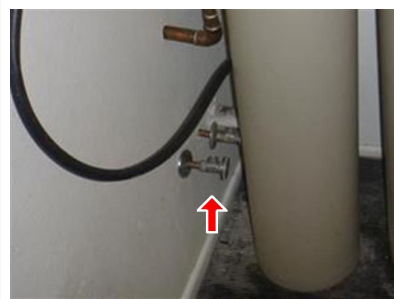
13.8 Item 1 (Picture)

There is plumbing for a laundry sink in the laundry room. The area in front of it is occupied by the water softener.

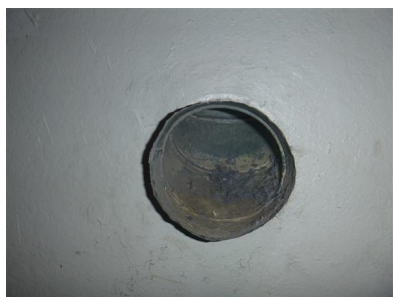
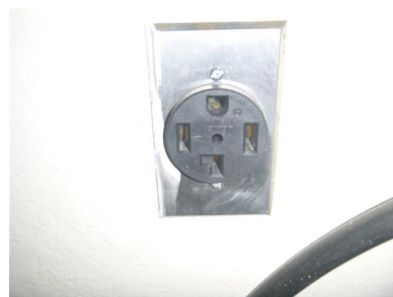
Dryer connections.

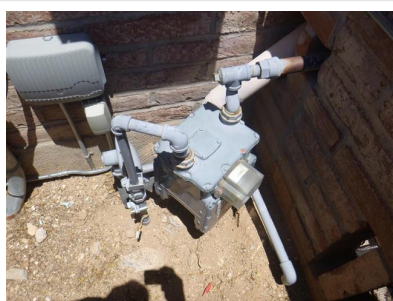
13.12 Item 1 (Picture)

The gas meter was located at the of the home. A bonding wire was present at the building side of the gas meter pipe. The visible gas line appeared to be in generally acceptable condition.

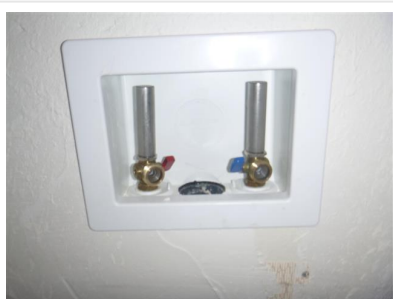
13.13 Item 1 (Picture)

The laundry plumbing appeared to be leak free and in good condition.

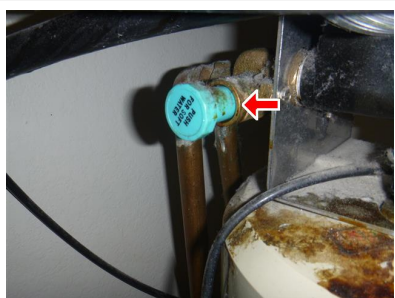
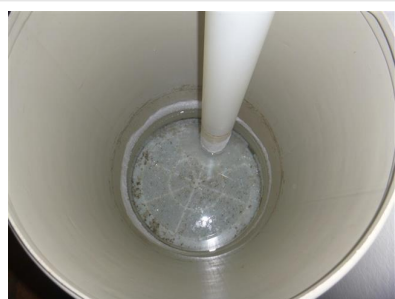
(1) There is a water softening system located in the laundry room. These systems were only visually checked for leaks. Water quality was not tested. The unit appeared to be in bypass mode and there was no salt in system at time of inspection. Advise further evaluation of system viability from a water softening contractor.

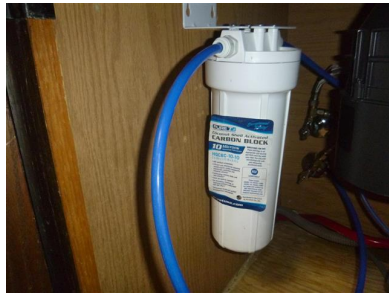
13.20 Item 4 (Picture)

(2) There is a cartridge water filtration system under the kitchen sink. This system was only visually inspected for leaks. The spout leaks when water is dispensed. The water quality was not tested. Advise repairs as needed by a qualified party.
